# Physical and mechanical control of *Crassula helmsii* and *Ludwigia peploides*. Is it a realistic option?

Johan van Valkenburg, INBO & Natuurmonumenten

Norwich, October 17th 2013

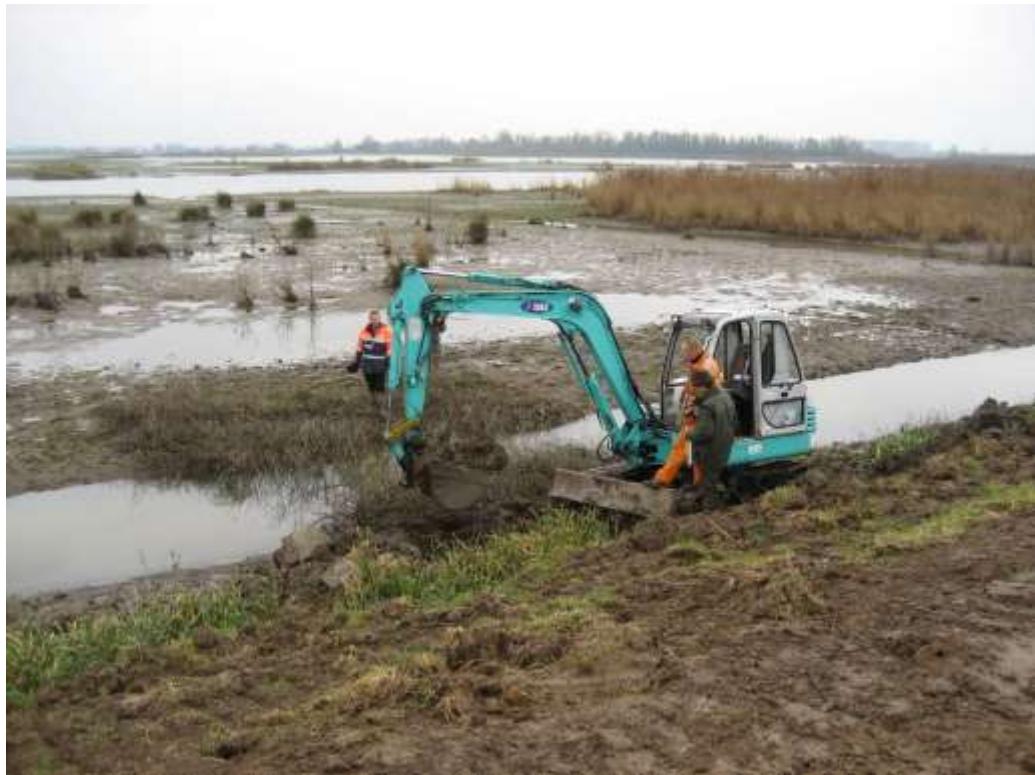
# Eradication November 2007

- Topsoil removal to a depth of 10 – 30 cm and contaminated soil to be stockpiled
- Emergent creeping vegetation marked and the soil excavated to a depth of 30 cm
- Drainage of ditches prior to excavation
- Holes to be dug at the site in areas where no *L.peploides* is present, and contaminated topsoil with fragments and plants to be buried at least 1 m deep.
- Reprofiling ditches and margins after removal

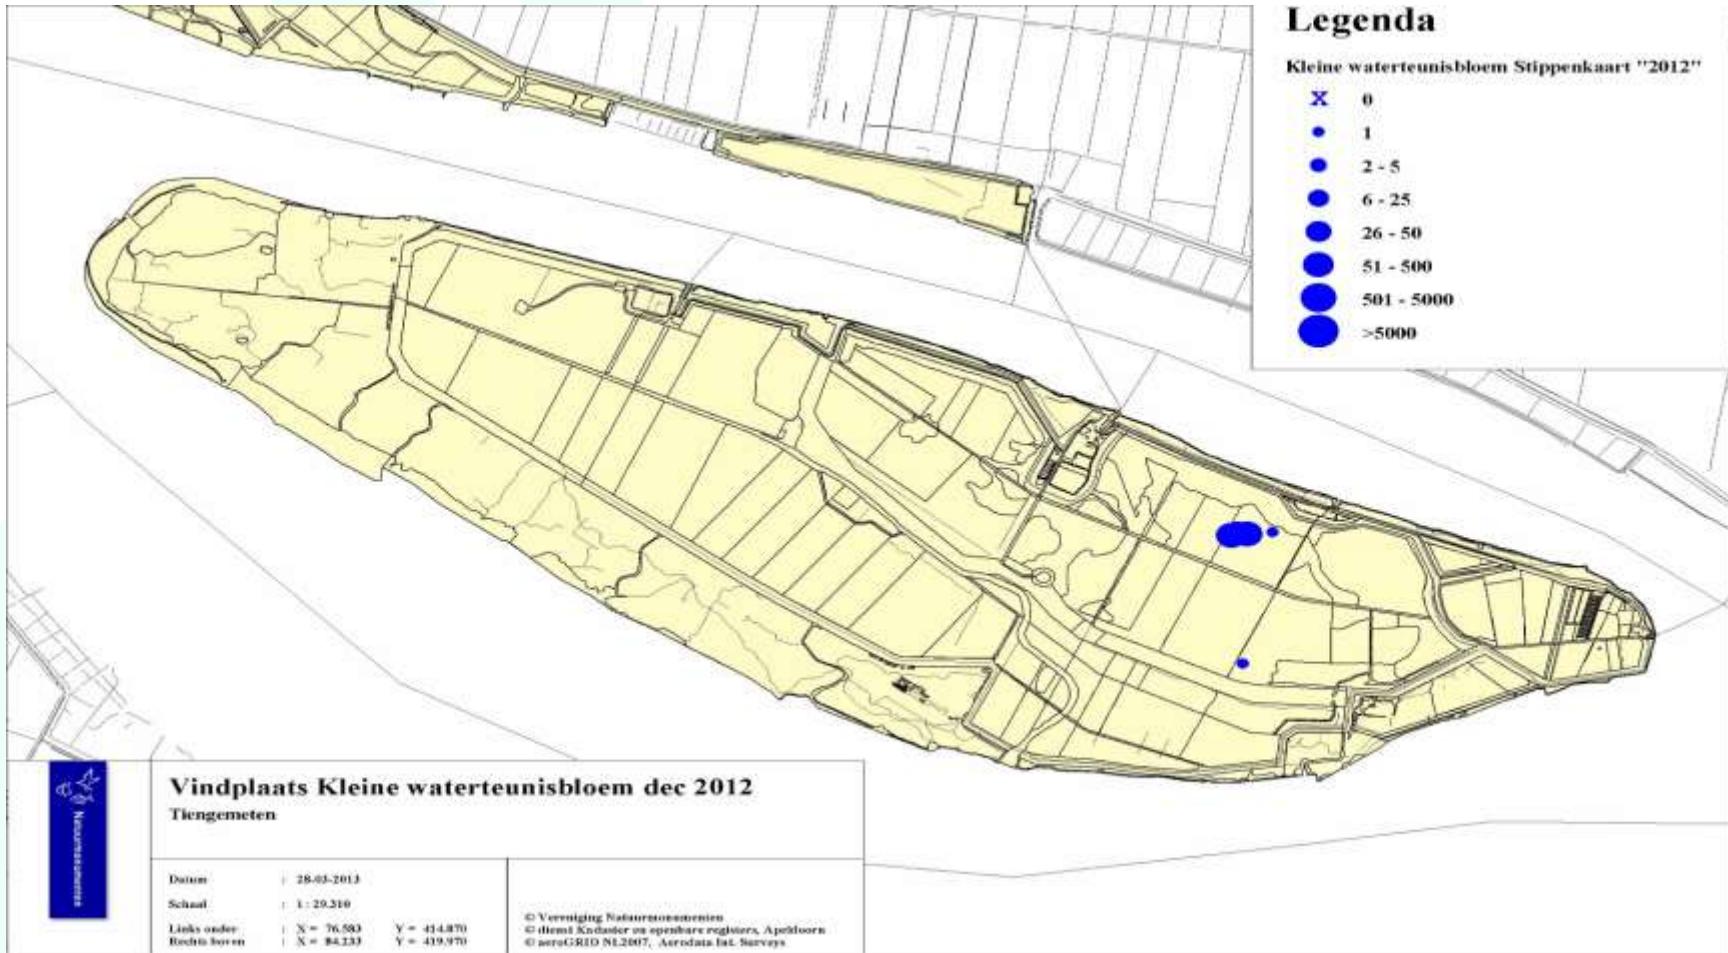
# December 2012 survey

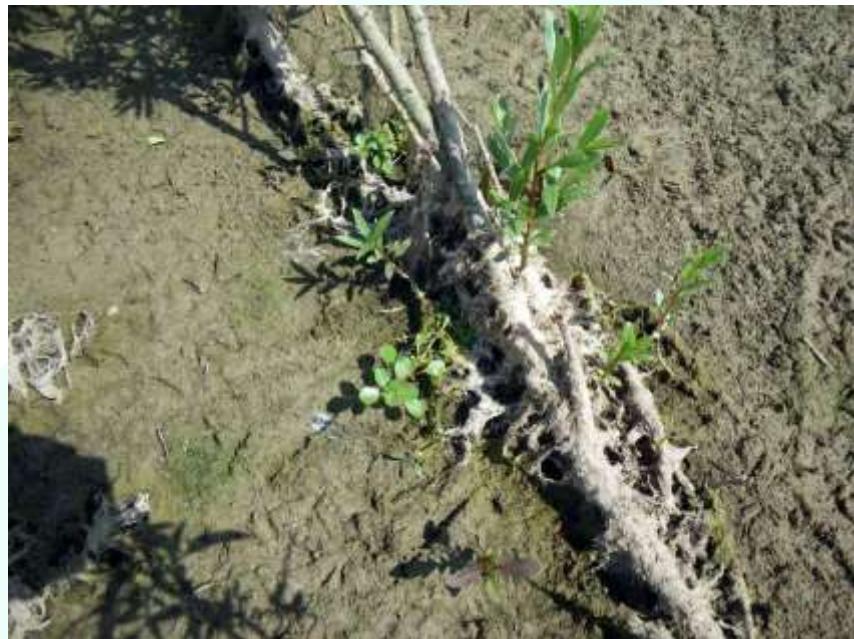
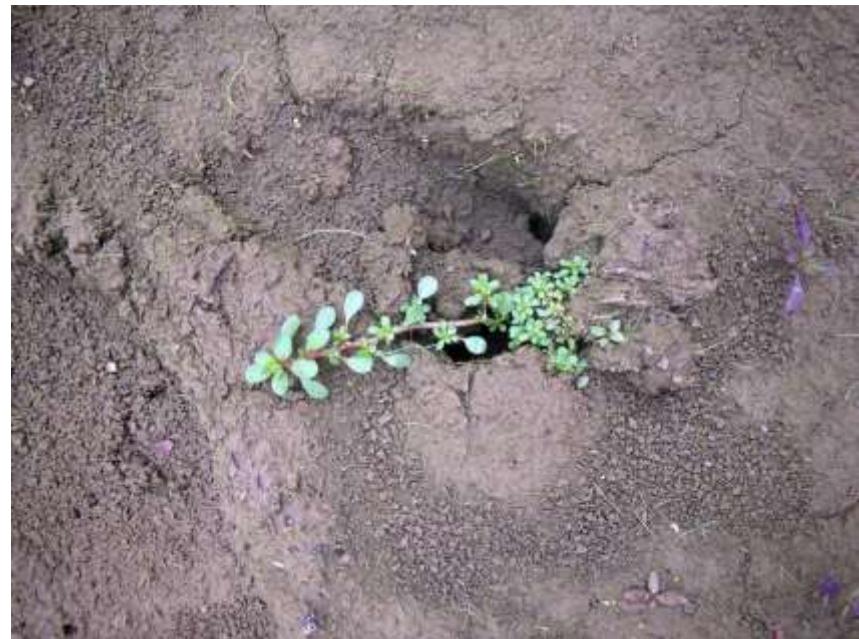
# Facilitators of establishment

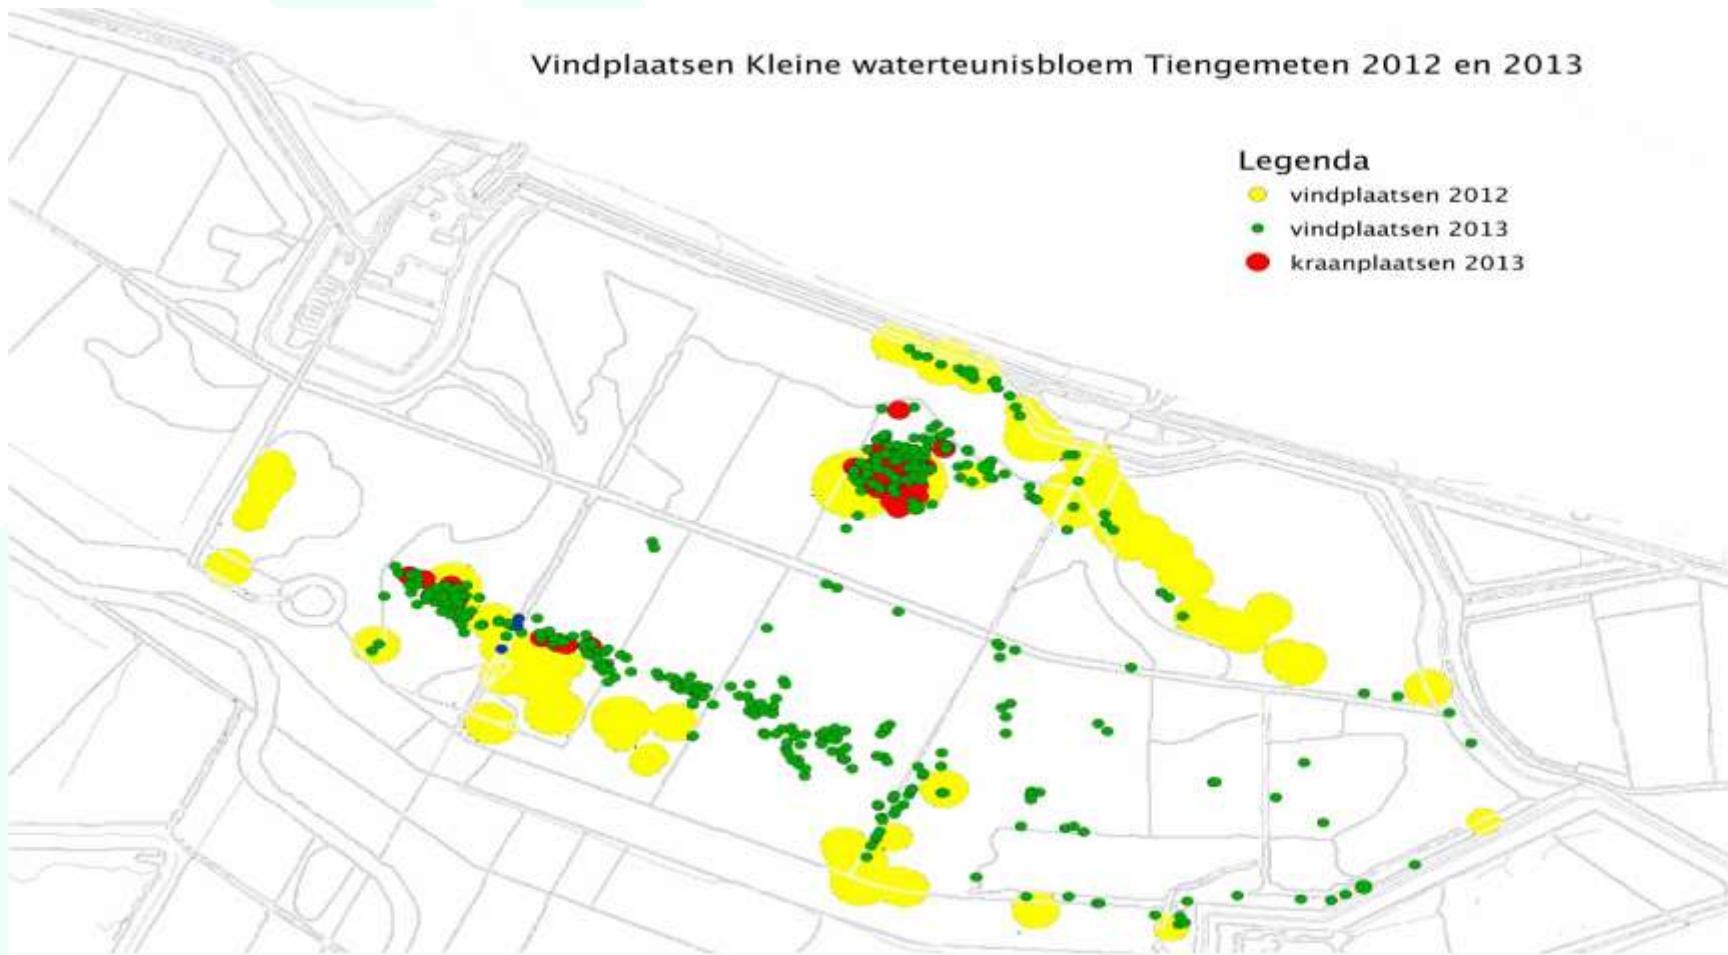
# Results 2013 survey regrowth treated sites and new infestations

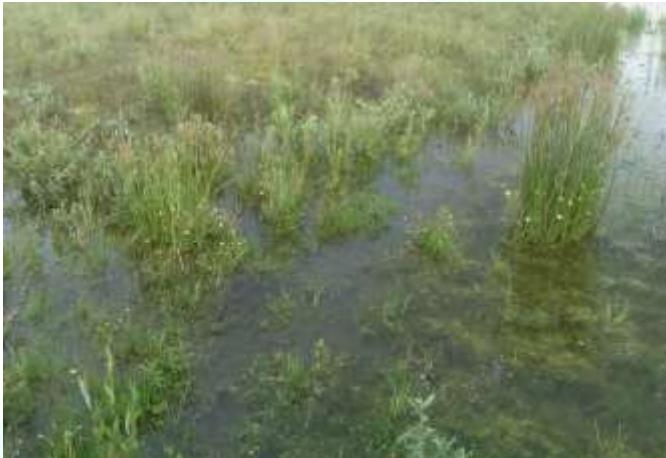
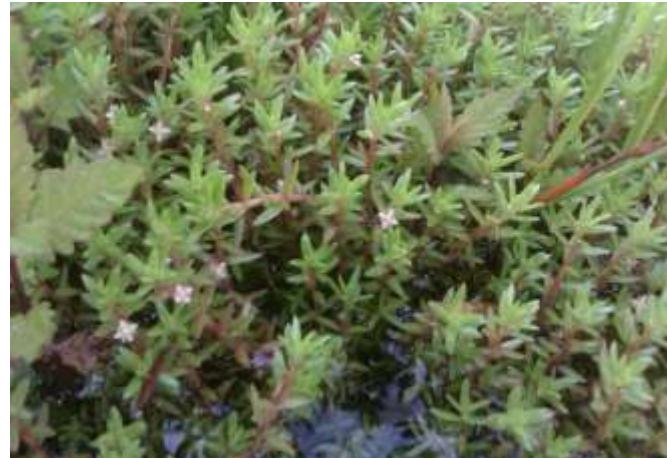
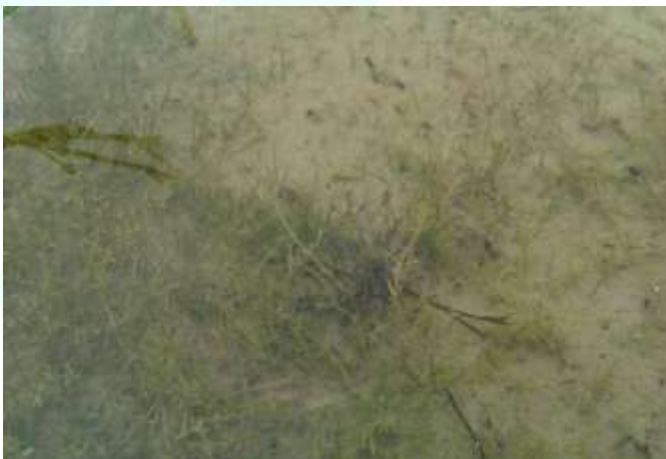
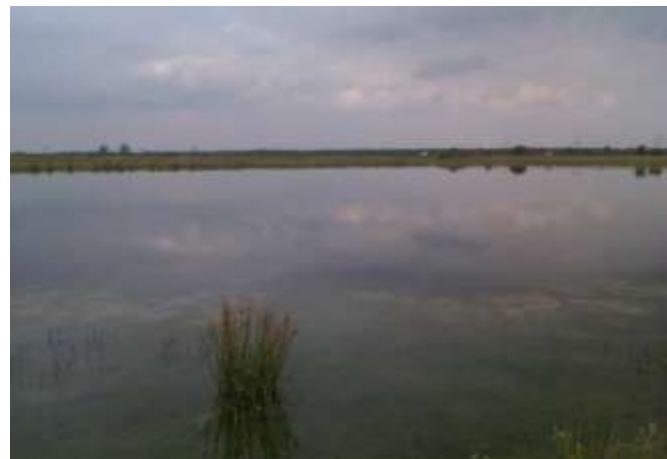
# Site visit June 2012

- Scattered plants on dry land
- Varying levels of infestation on the periodically flooded pools
- Massive infestations on the bank of the large pond
- Probably present at greater depth
- All infestations at some time of the year connected with the large pond

- Containment of the infestation
- Exclude grazers from the site
- Start draining the pond
- Remove topsoil upper 20 cm
- Burry contaminated soil on site

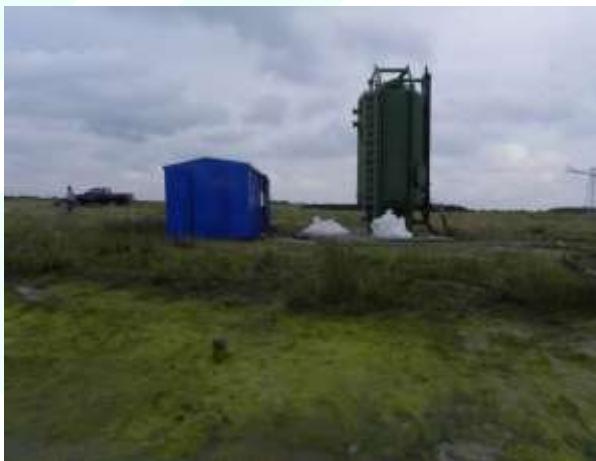
# July 2012 pump at full swing

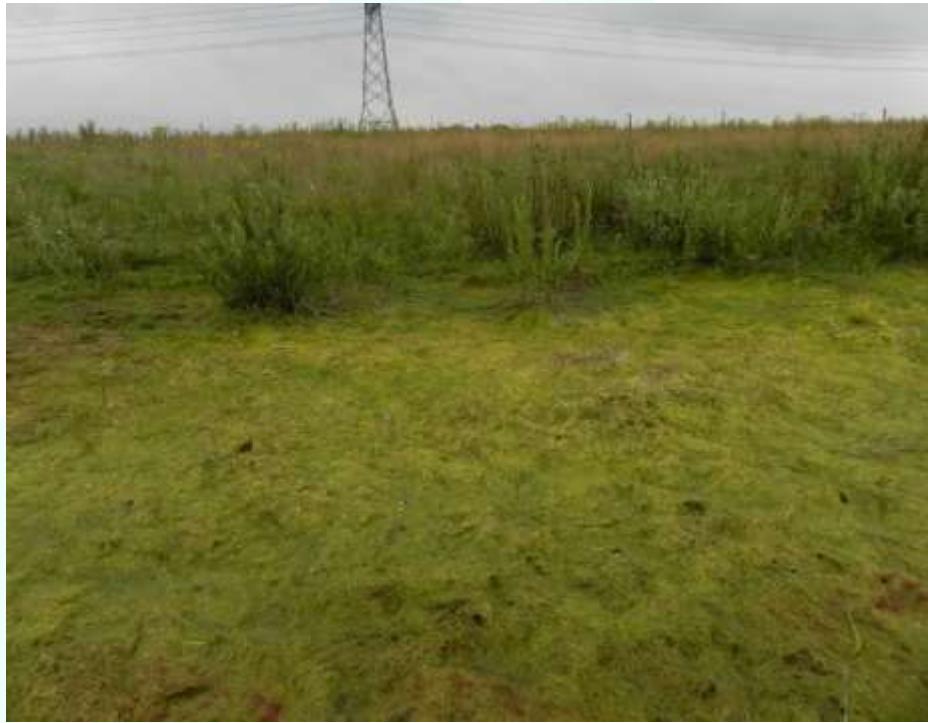
# July 2012 effect of drainage

- After weeks of pumping minimal achievable depth has been reached due to pressure from groundwater
- At centre of pond still 50 cm depth
- Start of removal of 20 cm topsoil on drained pond and dry land areas

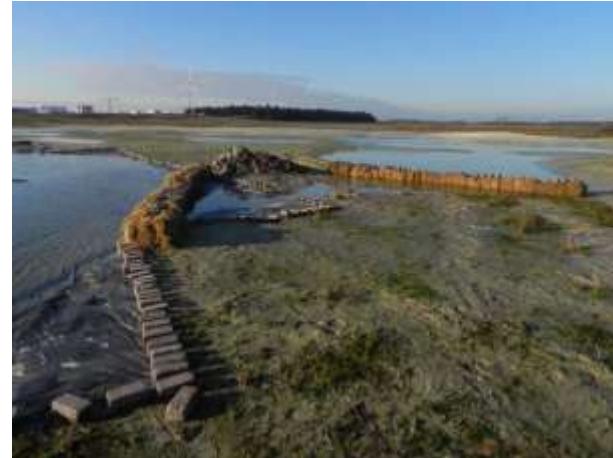
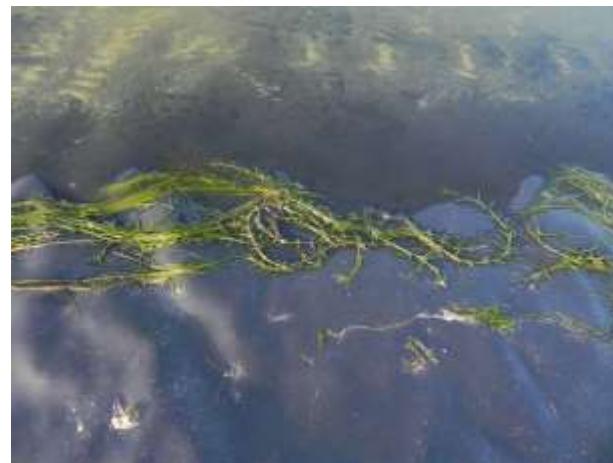
- Water level rising above initial covered surface
- Fragments washing ashore
- Volunteers cleaning shores every week

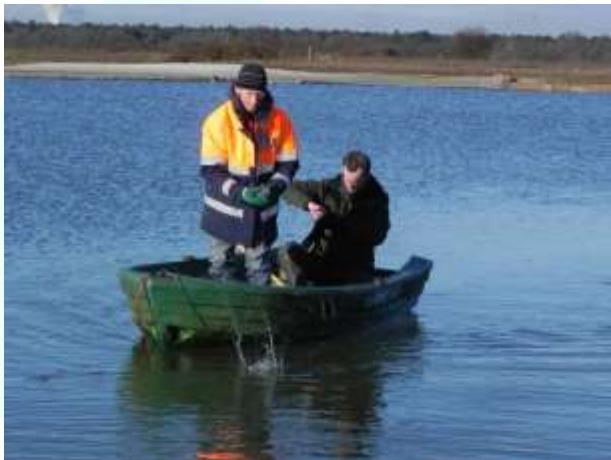
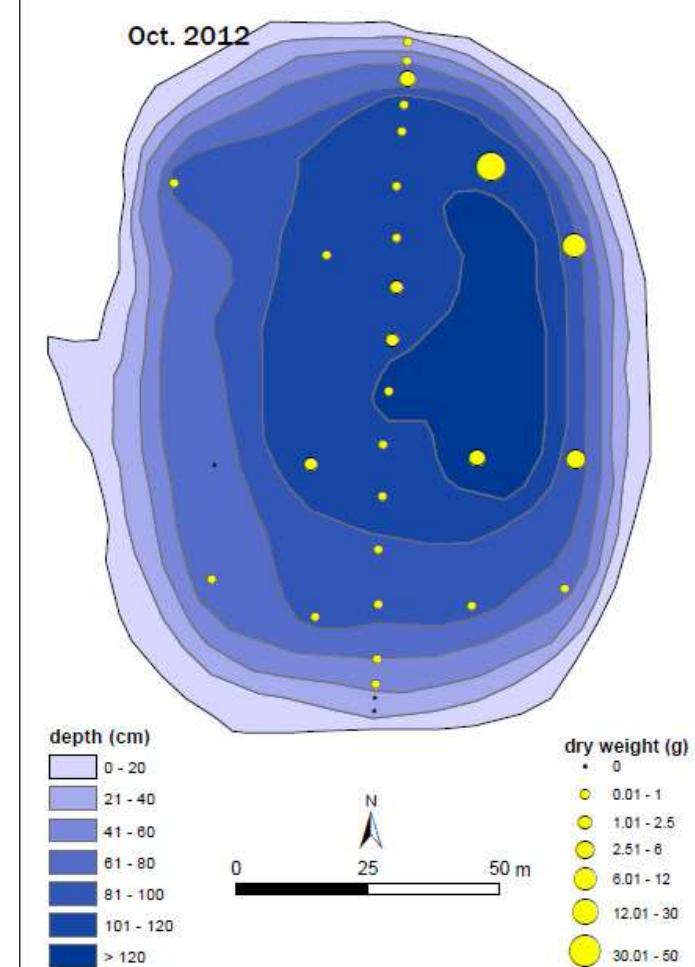
- First application  
January 16 kg
- Pond c. 150 m across
- Central part 150 cm  
deep

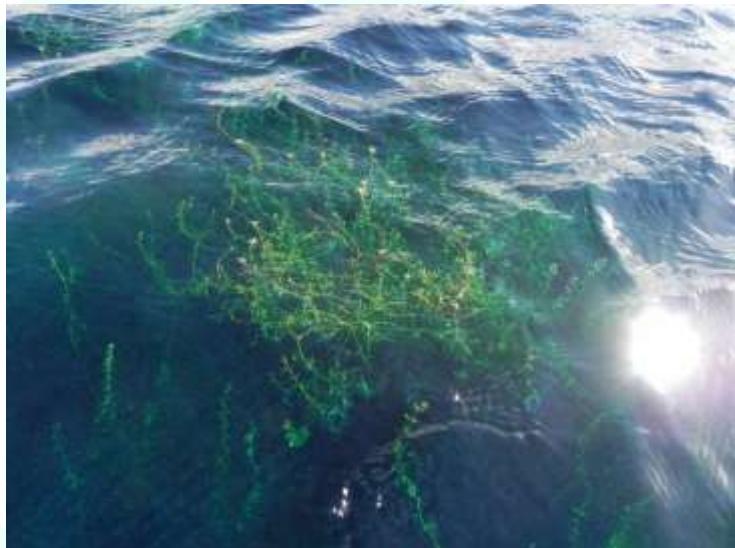
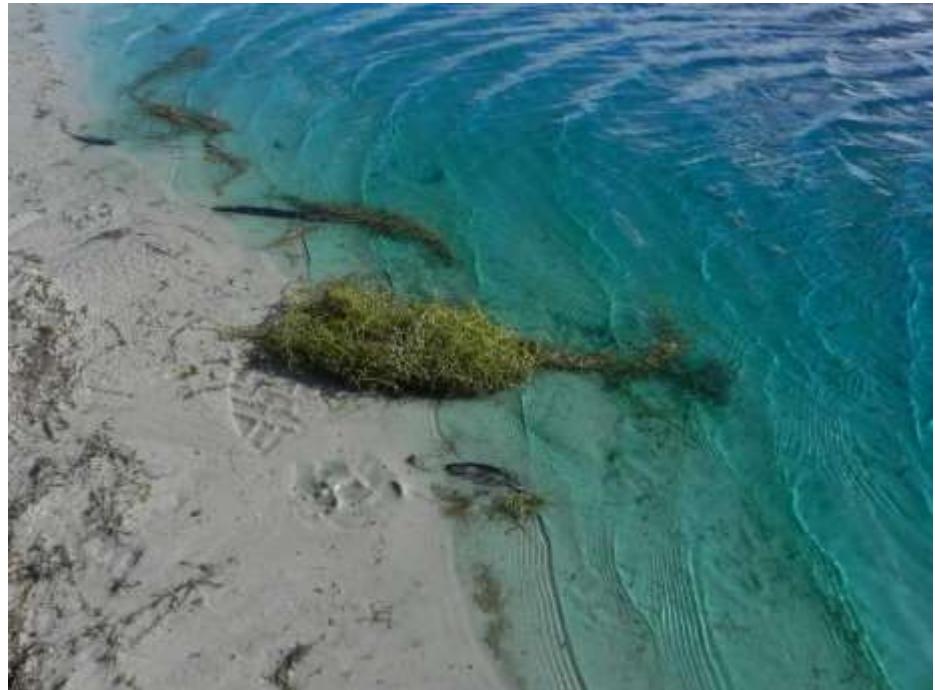
- Topping up March 14 kg
- 2nd load 30 kg August
