New Zealand pigmyweed

(*Crassula helmsii*)

Managing New Zealand pigmyweed in the Netherlands

RINSE project

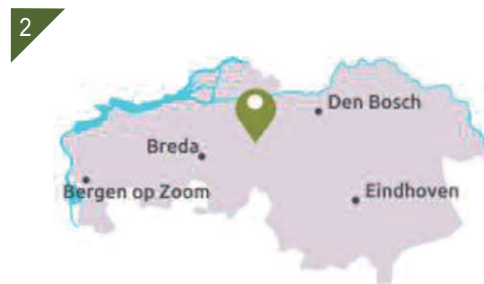
1. 2. Study site.

- In June 2012, an initial visit to the site served to characterise the situation prior to any work:
 - NZZ was in the process of dispersing in the emergent riparian zones;
 - the degree of colonisation varied depending on the dry period for the pools and ponds;
 - the plants were massively present on the banks of the largest pond and were probably present below the water surface;
 - all the colonised areas were in contact with the main pond during the wettest part of the year.
- Following the initial visit, the objective of the management work was to limit the spread of NZZ by:
 - prohibiting grazing by animals that can disperse the plants unintentionally;
 - emptying the main pond;
 - removing the top 20 centimetres of soil;

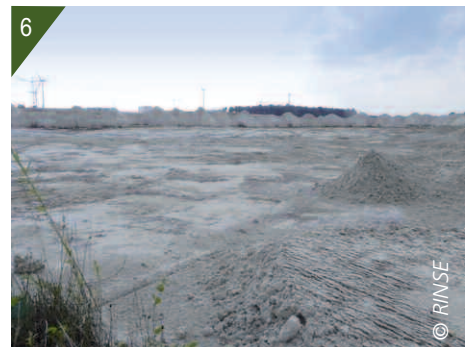
- The results in the emergent areas of the site were very encouraging. No regrowth has been noted to date following the removal of 20 centimetres of topsoil and the installation of the tarps.
- On the other hand, the results in the pond were mixed:
 - there was no significant reduction in NZP after the initial use of the dye, even though the recommended dosage (100 µg.l-1) was exceeded each time;
 - the reduction in the luminosity achieved by the dye was insufficient, except in the deepest part of the pond and for very short periods.

3. 4. The colonised pond, prior to the work.
5. Dredging work.
6. Site following the work.

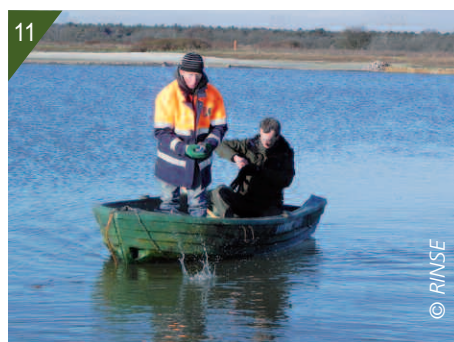
- The use of Dyofix (an anti-algal, triarylmethane dye) was planned. This dye limits luminosity in the aquatic environment, thus hindering photosynthesis and plant growth.
- In October 2012, the application for a waiver to use Dyofix was submitted.
- Voluntary personnel monitored the ponds on the entire study site. NZP was detected on two new sites.
- New management recommendations were implemented:
 - the exposed banks of the pond were covered with opaque sheets of plastic (tarps);
 - monitoring sites were established;
 - newly colonised sites were reported and eliminated or isolated;
 - monitoring was set up for NZP fragments that drift off and colonise neighbouring sites.

7. 8. Laying of the plastic tarps.
 9. Creation of the monitoring sites.
 10. NZP fragments following the use of Dyofix.
 11. Spreading Dyofix in the water.
