Water primrose

Managing water primrose in the Vistre basin

Public river-basin territorial agency for the Vistre basin

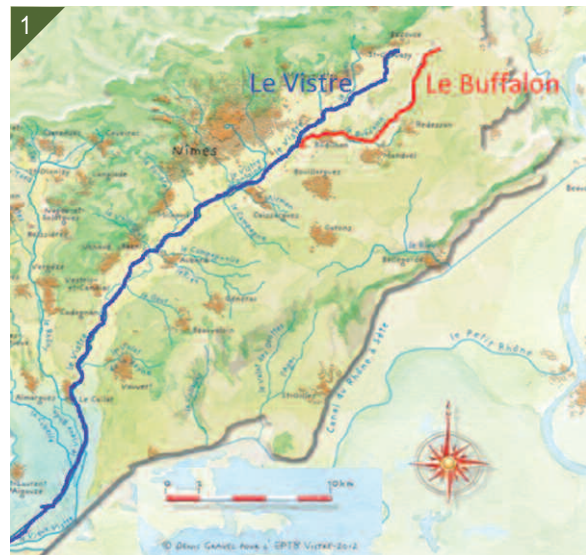
1. Territory managed by the Vistre EPTB.

- The EPTB manages an area of approximately 790 square kilometres and 185 kilometres of river.
- The Vistre River originates in the town of Bezouze, to the north-east of Nîmes, and flows into the Rhône canal at Sète, to the north of Aigues-Mortes.
- In 2009 and 2010, management of water primrose was conducted primarily on sections of the Vistre, in nearby wetlands and on two tributaries, the Buffalon and the Tavernolle.
- Starting in 2011, in an effort to optimise management operations, the work was more focussed, targeting heavily colonised wetlands and the areas around the work sites of the previous years, in the towns of Bouillargues and Nîmes.

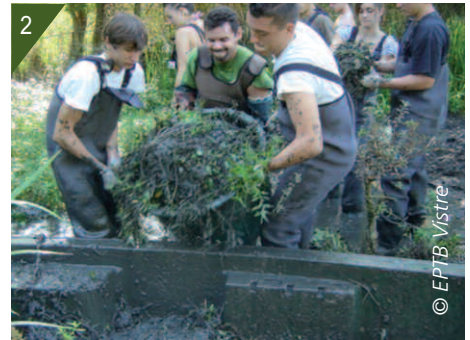
2. Uprooting water primrose with a school class in 2011.
3. Tarp covering an area colonised by water primrose.
4. Situation after 7 days of being covered by a tarp.
5. Situation after tarping and manual uprooting.
6. Site tarped in 2012 and naturally recolonised by native species in April 2013.

- Annual publication of a report titled *The work to uproot water primrose in the upstream sections of the Vistre basin*.
- Partnership with a class from the Rodilhan agricultural school for a half-day of uprooting in 2010, 2011 and 2012.
- Project to publish a brochure and fact sheets on the work done.
