Water primrose

Managing water primrose using mechanical uprooting and sediment dredging

Beuvron basin management board (SEBB)

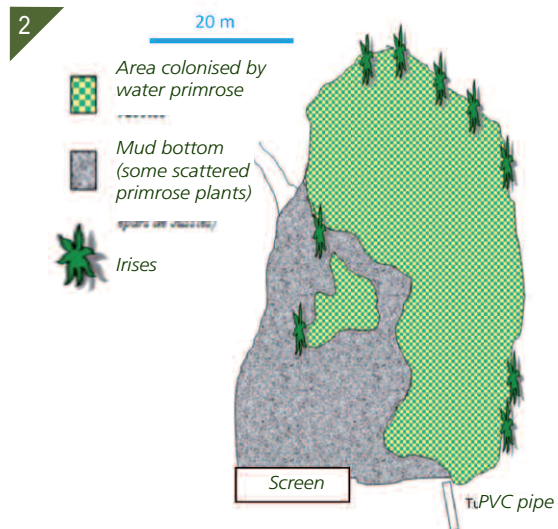
2. Colonisation of the pond by water primrose, prior to the intervention.

- Following an informational meeting in 2004 on issues surrounding water primrose in Sologne and an open-house in 2005, the Pays-de-Grande-Sologne board decided to test mechanical uprooting of water primrose in a local pond.
- The test took place in the town of Souvigny-en-Sologne thanks to a land owner who took interest in the project. Two ponds on the property were colonised by water primrose and it was decided to conduct the test on the smaller pond (1 850 square metres) located upstream of a string of three ponds.
- In 2007, when the project began, water primrose had colonised two-thirds of the total surface.
- The pond was drained before the work was undertaken.

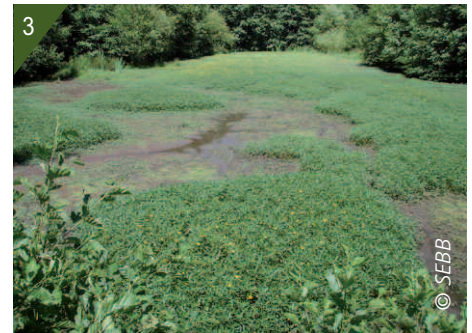
3. The drained pond.

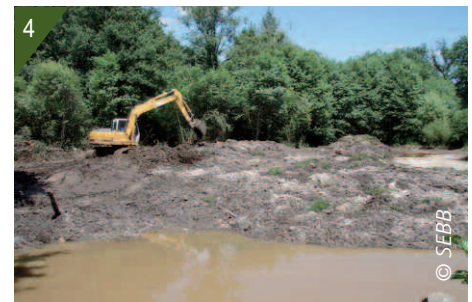
4. Work to uproot the plants and strip the top layer of sediment.

- The plants were uprooted and removed using a tracked excavator, a tractor and a trailer.
- For the test, it was decided to remove the water primrose, the plant litter and 40 centimetres of sediment (on average) in order to limit regrowth by cuttings and seeds (removal of all roots and seeds).

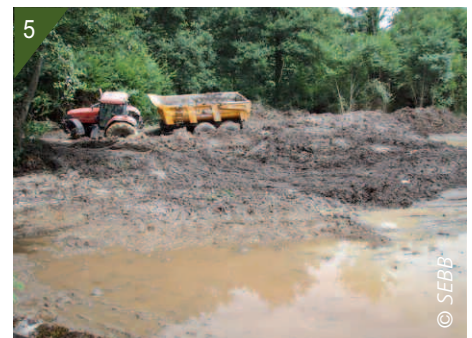
5. Removal of the plants and sediment.

- The plants and sediment were transported by tractor and trailer to a meadow. Every effort was made to limit the passage of the excavator in the beds of primrose to avoid dissemination of the plants.
- The waste was spread in a nearby meadow. It was planned not to create mounds, but a layer approximately 10 centimetres thick.
- The waste was spread only in the top section of the meadow in order not to cover typical wetland plants present in the lower section.

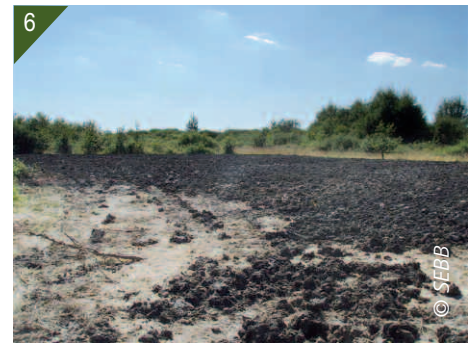
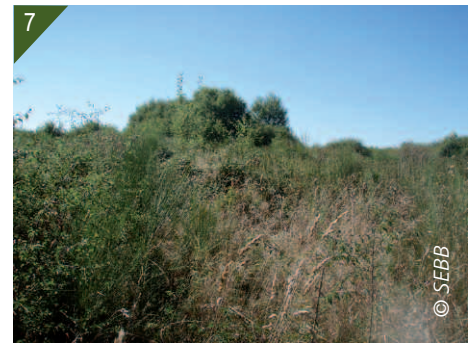
- The owner was trained to identify water primrose so that she could carry out manual uprooting herself.
- * Monitoring of the meadow where the waste was spread:
 - the drying time was longer than planned given the thickness of the spread material;
 - in 2009, the very hot summer resulted in the disappearance of the stands of reeds in the meadow and the appearance of grasses;
 - in 2010, wetland plant species such as reeds and hemp-agrimony (*Eupatorium cannabinum*) reappeared, signalling that the soil on the site still contained a high degree of humidity;
 - in 2013, the plant community in the meadow comprised grasses and shrubs (*Genisteae* (brooms) and blackthorn), similar to the situation before the work. The species observed in 2010 were no longer present.

6. 7. The meadow prior to the work (2008) and in 2013.
