Asian knotweed

Managing Japanese knotweed in the Gardons basin

Board for balanced management of the Gardons basin (SMAGE)

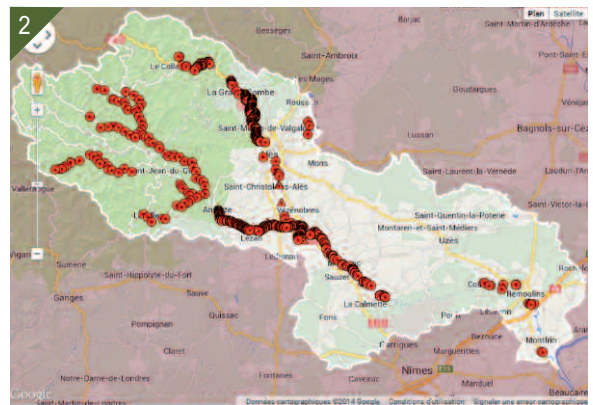
2. Map showing the location of Japanese knotweed colonies. Note. The map above shows all the known sites. The surveys were conducted with varying degrees of accuracy and the density of points does not necessarily correspond to the actual degree of colonisation. The map should be interpreted as simply indicating the presence or the absence of knotweed.

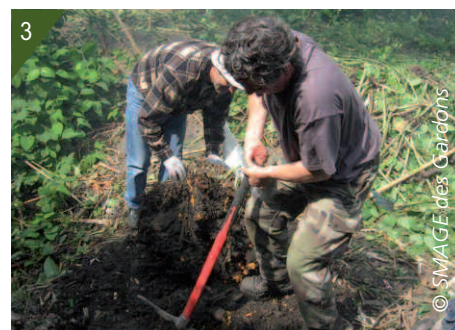
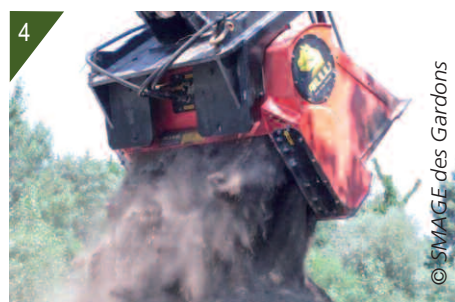
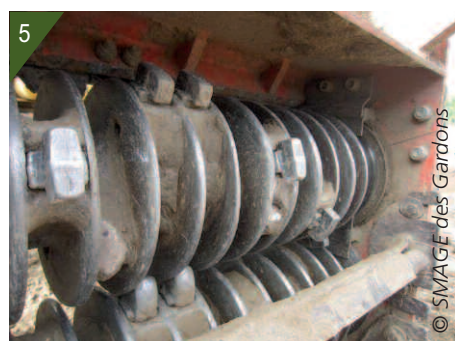
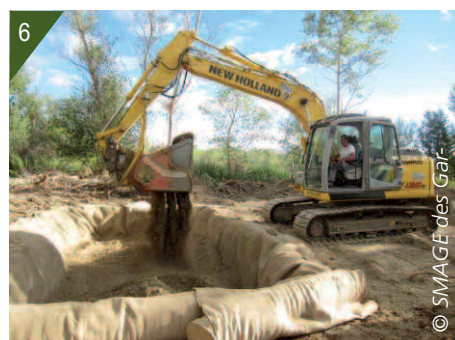
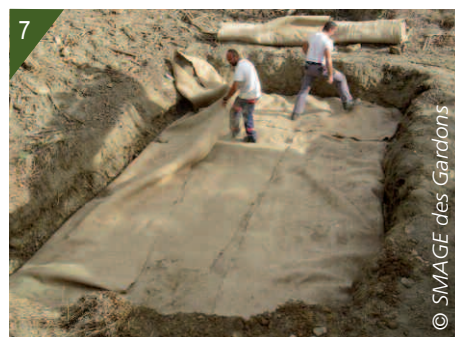
3. Manual uprooting of knotweed.
4. The uprooted material is sent two or three times through the grinder.
5. Grinder in the bucket.
6. The ground material is deposited in the hole from which the plants were uprooted.
7. It is then covered with a biodegradable fabric.

- the waste was sent through a crusher-grinder bucket two or three times on site;
- the waste was returned to the hole and covered with a tarp to inhibit regrowth and accelerate rotting of the rhizomes;
- the tarps were then covered with healthy soil from the site to reduce any risk of the waste being exposed during flooding;
- any regrowth from dispersed fragments was uprooted the following year;
- the sites are monitored.

■ Initially, the technique called for plastic tarps to be used to cover the waste. However, given that plastic tarps had to be mechanically removed and that the sectors spanned a large area (20 km) subject to flooding, it was decided to use a thick, biodegradable fabric made of hemp and burlap (1 200 grammes per square metre).

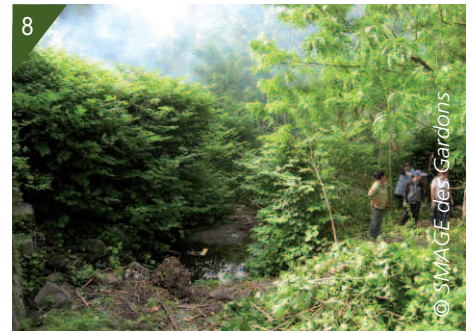
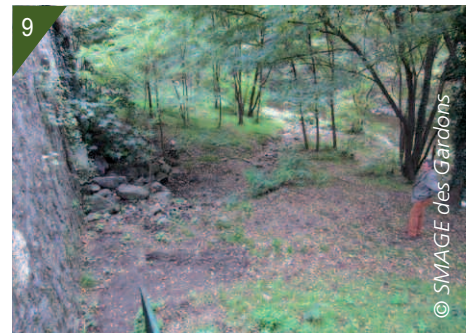
8. 9. The Grand'Combe sector colonised by Japanese knotweed in 2009 and after the work in 2013.

■ On the Grand'Combien site, five years after the intervention, the results are very positive. The knotweed has retreated along the entire river section and only rare shoots may now be found. The general public is present on the banks much more often and the quantity of waste thrown by local residents from the road has dropped regularly. The work using unemployed people had a positive social impact in that the project was fully supported by the employees of the Cévennes development association (TEDAC) and approved by the local residents.

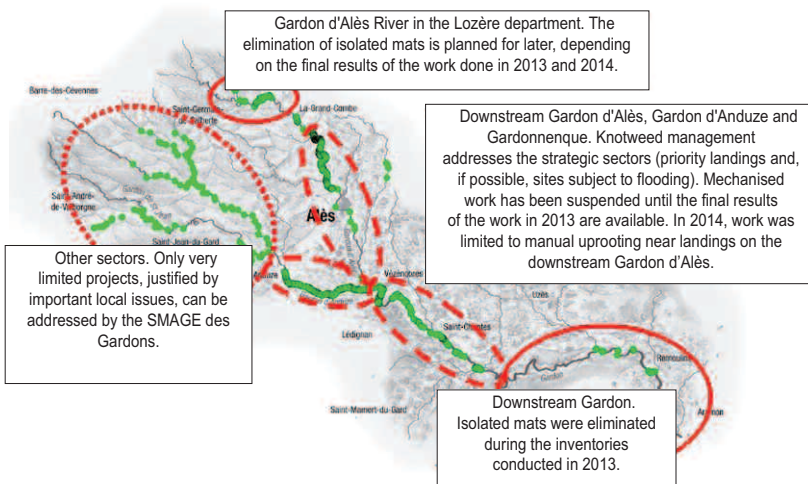
Map showing the location of Japanese knotweed along the Gardons Rivers in 2013 (prior to the work on the downstream Gardon d'Alès and the Gardonnenque). Green dots indicate the presence of Japanese knotweed.

Map showing the sites for the various techniques employed. © SMAGE des Gardons
