# Asian knotweed (*Reynoutria* sp.)

## Managing Japanese knotweed at the confluence of the Luye and Durance Rivers

### Development board for the Durance River basin (SMAVD)

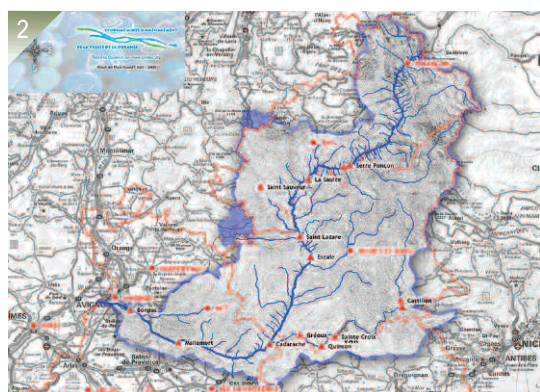
1.2. Intervention sites.

- The intervention zone is located in the towns of Curbans and Venterol in the Alpes-de-Haute-Provence department and in the towns of Saulce, Tallard, Lettret and Jarjayes in the Hautes-Alpes department. EU-listed habitats exist within

the intervention zone, including stands of grey alder and white willows. These habitats are home to a large number of EU-listed species, e.g. the black kite and the Eurasian beaver. A large number of invasive alien species (IASs) have also been observed, e.g. giant goldenrod, Kashmir balsam, box elder, Virginia creeper, pale galingale, ailanthus and summer lilac.

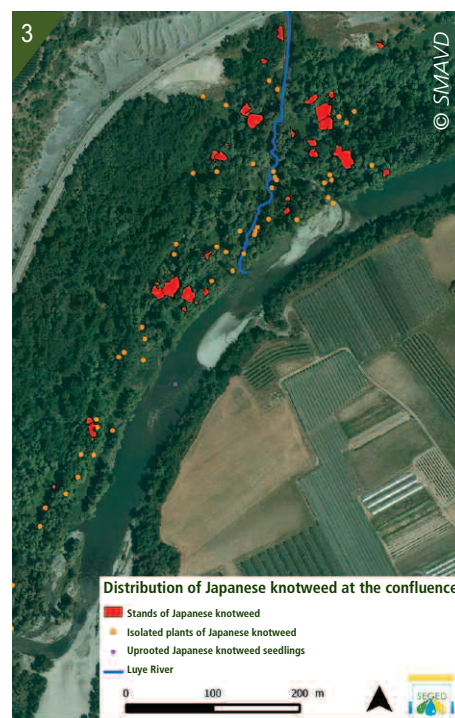
3. Distribution of Japanese knotweed on the study site in 2014.

■ The survey was carried out by two ecologists over a total of nine days during the months of April, May and June 2014. The technique consisted of walking along the foot of each bank and on the sand bars in the middle of the river, throughout the entire study area. Knotweed points (individual plants) and stands were located using a GPS device. Recorded information included the diameter and average height of the stalks, as well as the type of colonised environment. Stakes were placed around knotweed stands to locate them again more easily. A total of 28 stands as well as 59 points were staked out.

■ Along the Luye, numerous stands of knotweed upstream of the surveyed area represented a risk of contamination and caused a high concentration of Japanese knotweed at the point of confluence between the Luye and the Durance. Knotweed densities dropped with the distance downstream from the confluence. The observed plants furthest downstream were located six kilometres from the confluence.

■ In comparison with the surveys run in 2011, the overall number of points had decreased, notably on the right bank of the Luye, but new points had appeared along the upstream section of the river. Renewed growth was observed in several areas, notably the downstream section of the Durance where a point not observed in 2011 was also noted.

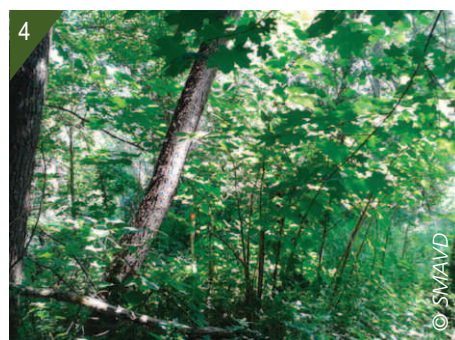
4. Japanese knotweed in the riparian vegetation.

■ In some places, other species can be eliminated by Japanese knotweed through competition and a reduction of sunlight. Large stands of knotweed reduce the diversity of habitats. The plant can snuff out the regeneration of other riparian vegetation. The habitat and its functions for other species are degraded.

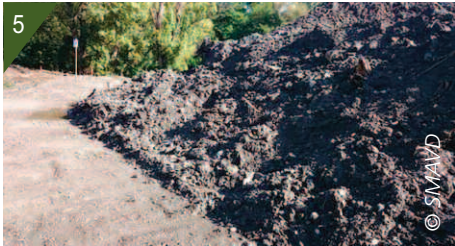
5. Rhizomes waiting to be ground up.  
6. Storage area.

- The soil was treated using the “grinding-tarping” technique. The soil was ground using a stone grinder to fragment the rhizomes and damage the fine roots:

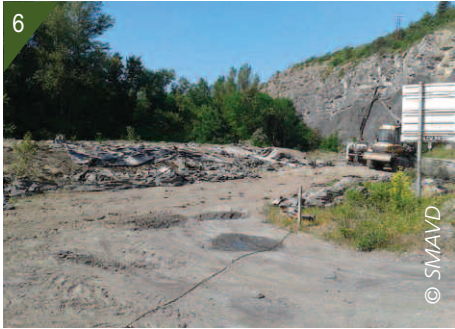
- a fence was put up to keep large animals from damaging the tarps.
- Two storage areas, 3 047 and 3 900 square metres in size, were created, the first on the left bank and the second on the right bank of the Luye. At the end of the work, a control group of rhizomes was laid out on each storage site to monitor the rotting process. Each group comprised five rhizomes with two nodes and five with one node, buried ten centimetres under the ground and tarped soil.

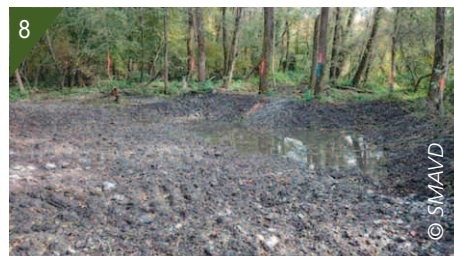
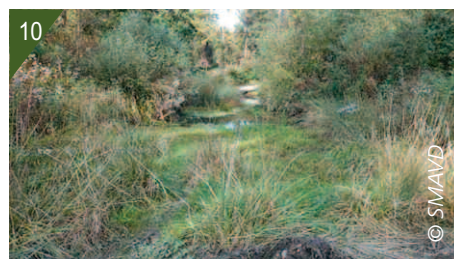
8 and 10. Excavated ponds

■ It was finally decided not to plant willow cuttings on certain sites because some excavated areas were of more ecological value as a string of ponds. A number of large excavated areas were partially planted with willow cuttings to create shade for those areas. The access tracks were restored and replanted. The fence was checked and all cables were tightened. The tarps were checked to ensure that they were still correctly positioned.

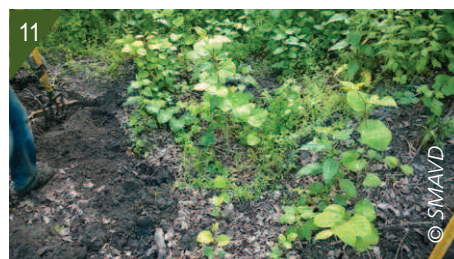
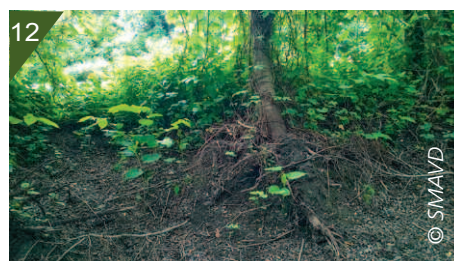
- on the left and right banks of the Luye, a few rhizomes were collected in the bottom of the excavated areas. A larger number of sprouts were found among the vegetation developing on the vertical banks of the excavated areas. They continued well beyond the two metres around the knotweed stands marked with stakes. The plants and rhizomes were completely uprooted. On the tracks, five rhizome fragments were collected;

■ Two stages of vegetation development were observed. First, a number of very young plants sprouting from small fragments of rhizome rootlets, and secondly, a more advanced stage of plants with stalks 20 to 40 cm high, sprouting from rhizomes cut during the excavation work. Given the differences between the two stages, prolonged monitoring of the sites was considered necessary. All the sites were inspected again in June 2016. A volume of plants equivalent to 15 bags containing 80 litres each (1.2 cubic metres) was removed, primarily from the sides of the excavated holes and from the root system of the trees.

11 et 12. Knotweed shoots sprouting from rhizomes in the soil. June 2016.

- Following a new assessment, the new sprouts will be treated in 2017. The storage areas will be restored to their original condition in 2018.
