## Water primrose

### Testing a method to eradicate water primrose from two ponds in Acigné (Ille-et-Vilaine department)

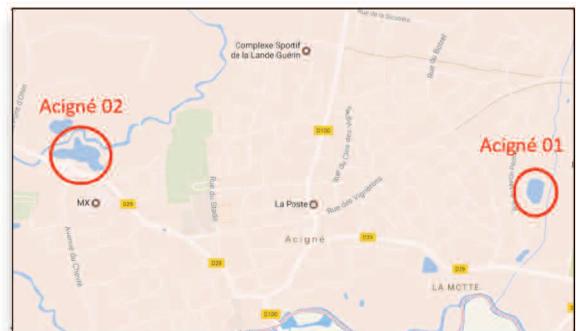
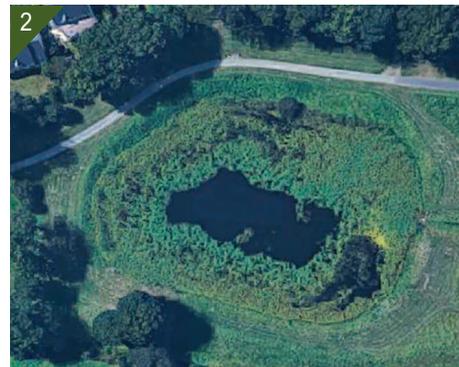
1. Maps showing the two ponds in the town of Acigné.
2. Aerial view of the buffer pond (Acigné 01).
3. Aerial view of the second pond (Acigné 02).

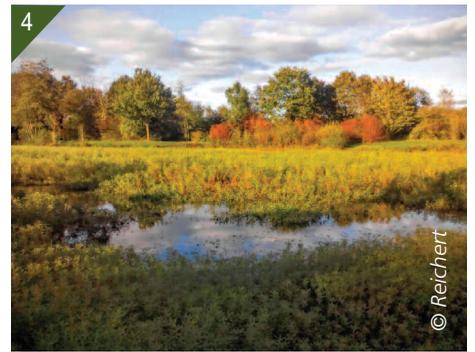
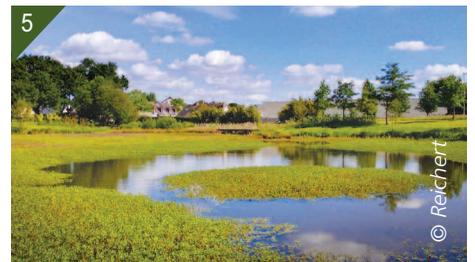
■ The two ponds were heavily colonised by water primrose (70% in Acigné 01 and 90% for Acigné 02), a situation that limited the development of the fauna and flora on the sites.

4, 5. Acigné 02 pond, prior to the work.  
6. Mechanical uprooting in Acigné 02.  
7. Filtering system during pumping of Acigné 02.  
8, 9. Removing the surface soil in Acigné 02.

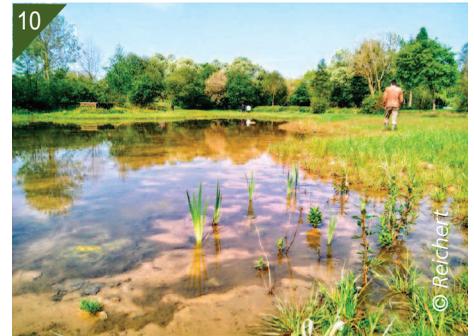
10. Reed bed in pond Acigné 02 (after the work).

- Reed beds were planted around the two ponds and meadow grasses were also sown around pond Acigné 02. Near pond Acigné 02, the plan was to preserve the reed bed to the south-east and to remove manually the water primrose growing there, but the colonisation turned out to be too extensive and the reed bed was finally removed.

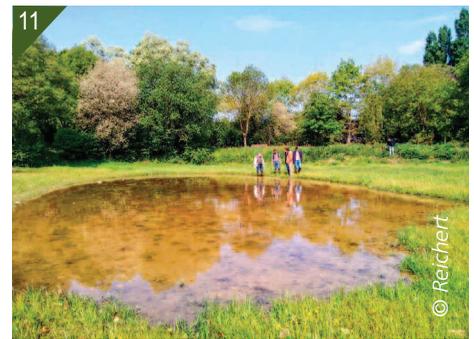
11. Pond Acigné 02 after replanting.

- Pond Acigné 02 was filled in without raising the initial topographic level in order to maintain the site as a wetland, but not a pond. The fill consisted of 50 to 70 cm of mineral soil, followed by 20 cm of top soil.
