# New Zealand pigmyweed

## Managing colonisation of a pond by New Zealand pigmyweed

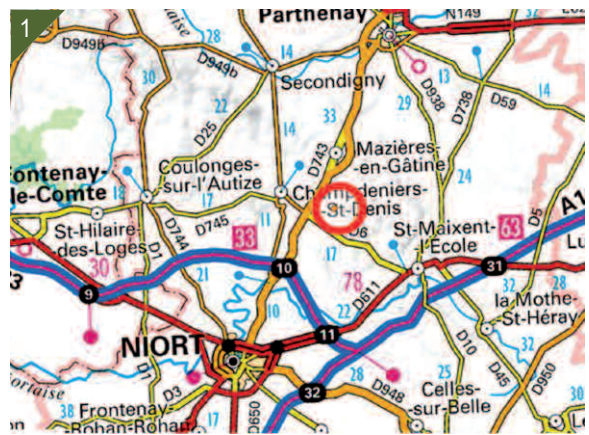
1. Intervention site

- Approximately 250 square metres (10 x 25 m) of the pond surface were covered by NZZ. The water depth varied from 20 to 60 centimetres with between 20 and 40 cm of sediment.
- The pond belonged to a farmer and was located along a road.
- The pond received water from a fountain, but was not connected to the aboveground hydrographic network. The nearest stream was the Raganier Stream, located 500 metres away.

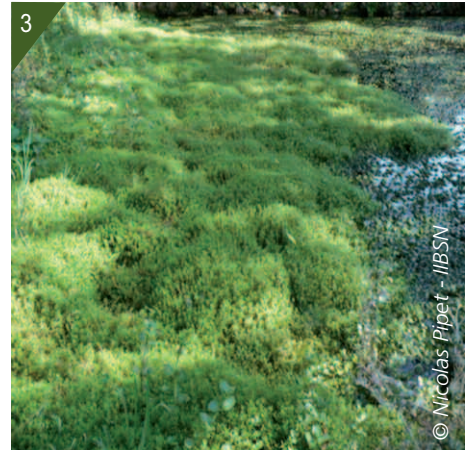
3. Beds of NZP.

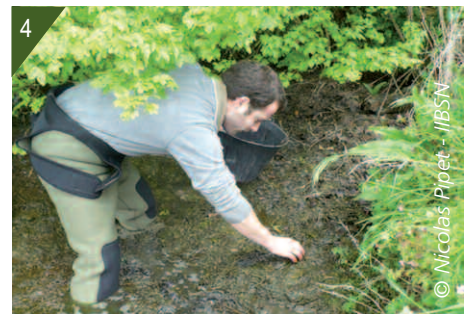
4. Manual uprooting of NZP.

■ The workers started manual uprooting from the middle of the pond and worked to the edges in order not to trample the colonised zones and avoid any risk of fragmenting the plants and driving them into the sediment.

■ The plants were collected in 10-litre buckets and then transferred to basins.

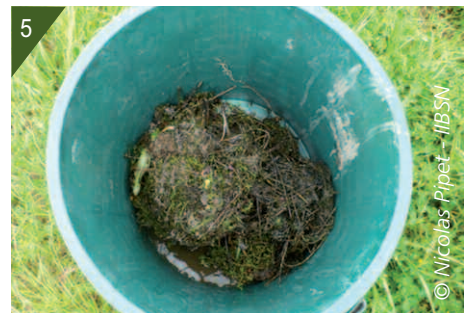
5. Plants ready for transportation.

■ The mechanically uprooted plants were stored on a hill approximately 100 metres from the pond. On the dry, relatively inaccessible hill, it was possible to monitor the changes in the plants following their transfer. The site also served for the plants uprooted manually.

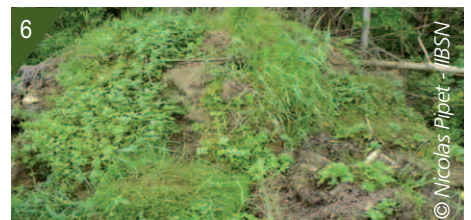
6. A pile of harvested plants.

■ A dry field located far from the wet areas was selected for plant storage to avoid any risk of regrowth and to monitor plant resistance to drying.

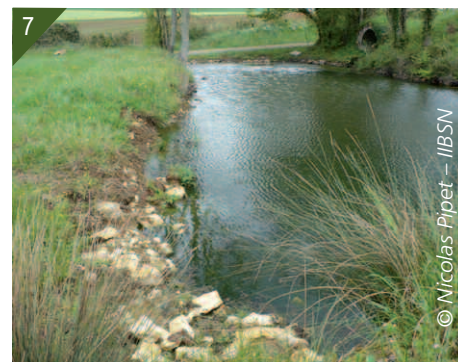
7. The pond after the work on 3 May 2012.

- Approximately 95% of the initial biomass was harvested.
- Between 3 October 2011 and 3 May 2012, the mechanised work reduced the surface areas colonised, but produced cuttings.
- The manual work was effective and fairly simple for the beds located in the pond.
- The manual work required a large amount of time.
- Starting in 2013, the work and monitoring was organised by the SIAH technician.
- The storage area was monitored to learn more about the harvested plants.
- Plant regrowth in the pond was monitored and manual uprooting was repeated 3 times per year (May, July and September).
- A precise assessment of the management work was undertaken to check the effectiveness of the work over several years.
- Contact was maintained with the farmer.
- Checks were run to ensure that NZP did not spread to nearby aquatic environments.
